Water Connector and Toilet Valve Failures

**What they are, How they fail,
and How to Evaluate Recovery
Issues**

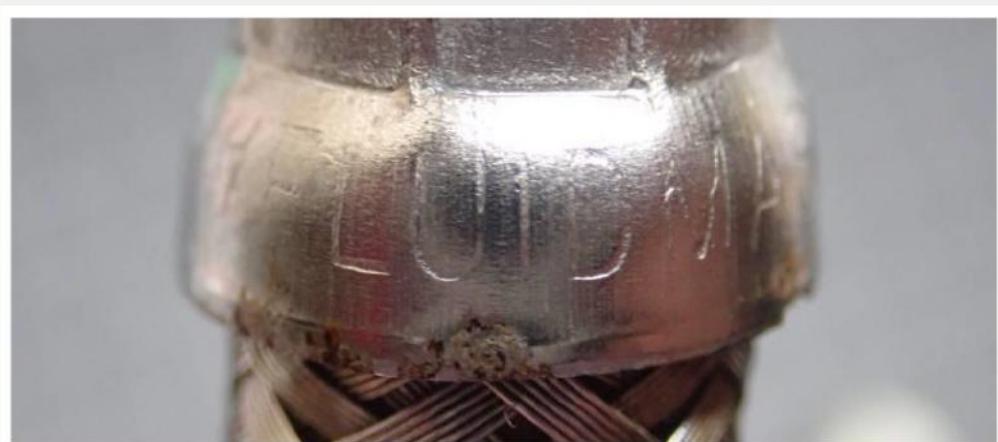
Photograph 2: Manufacturer's identification.

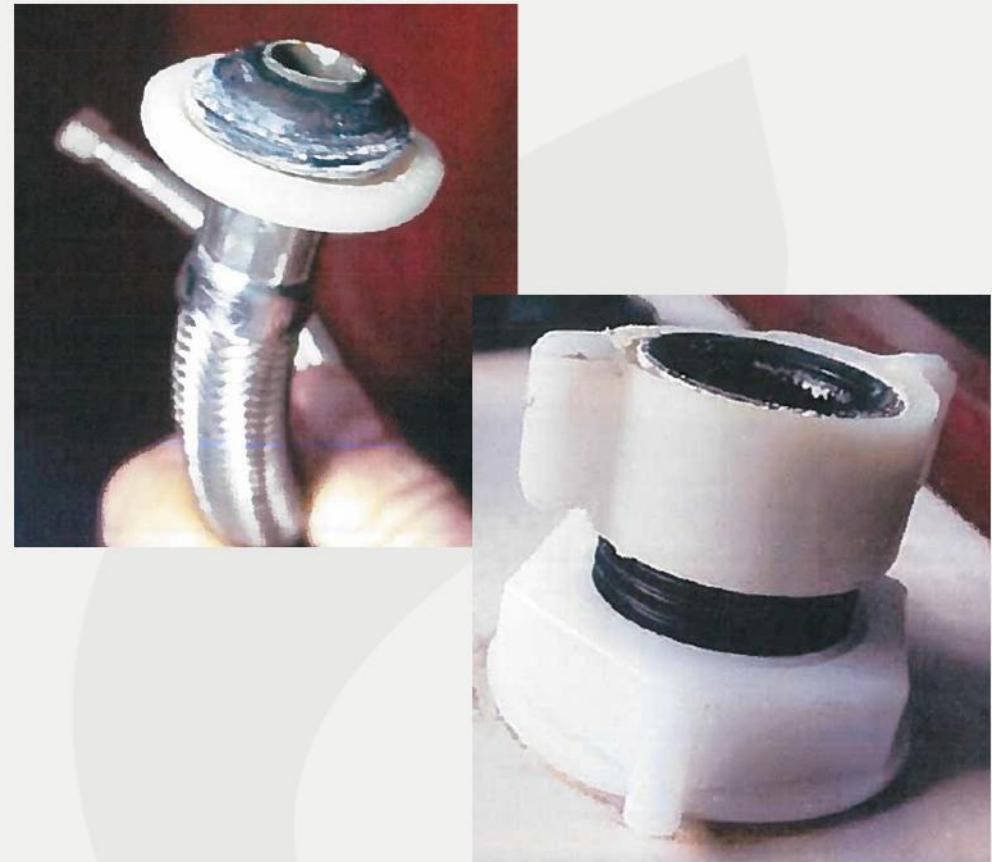
USUAL FAILURE MODE

- Circumferentially fractured;
- Eventual total separation of nut;
- Fracture starts at root at base of nut.

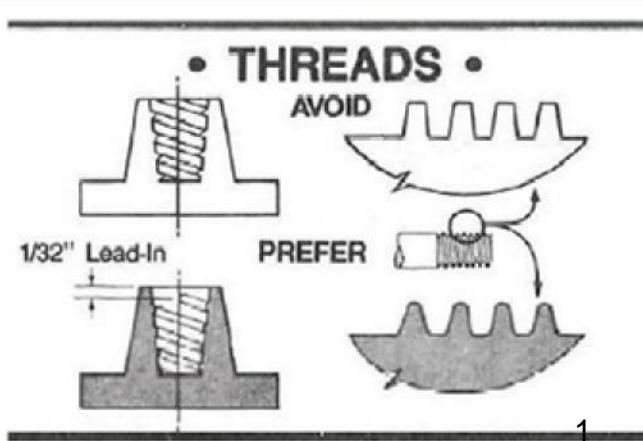
Design Defects Lead to Failures

1. Sharp teeth v. Rounded teeth
2. Sharp transitions at bottom and crest v. Rounded

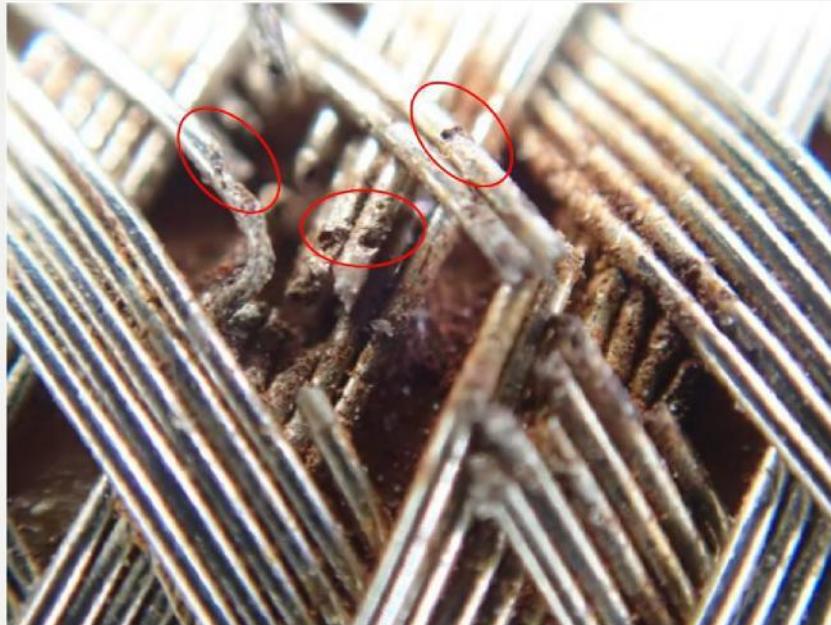
Corroded and broken stainless steel braid and burst inner tubing

CAUSE:

Exposure to common household cleaning products containing chlorine/chlorides (chlorine-induced stress corrosion cracking)

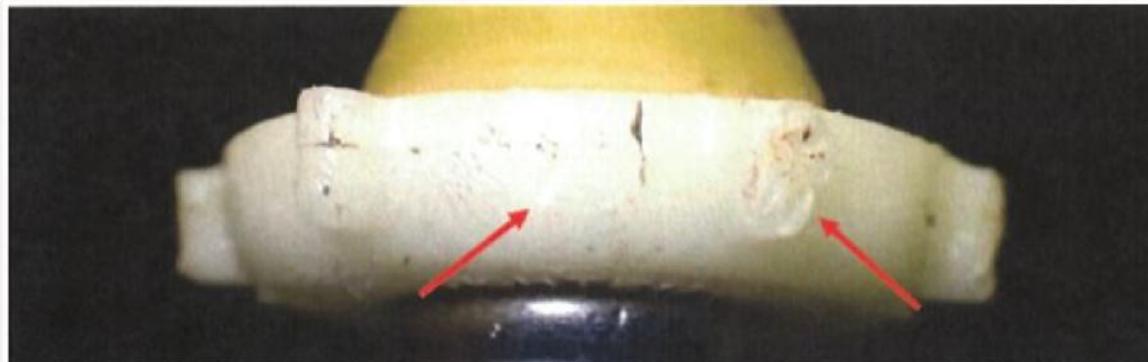
Tool marks found on coupling nut.

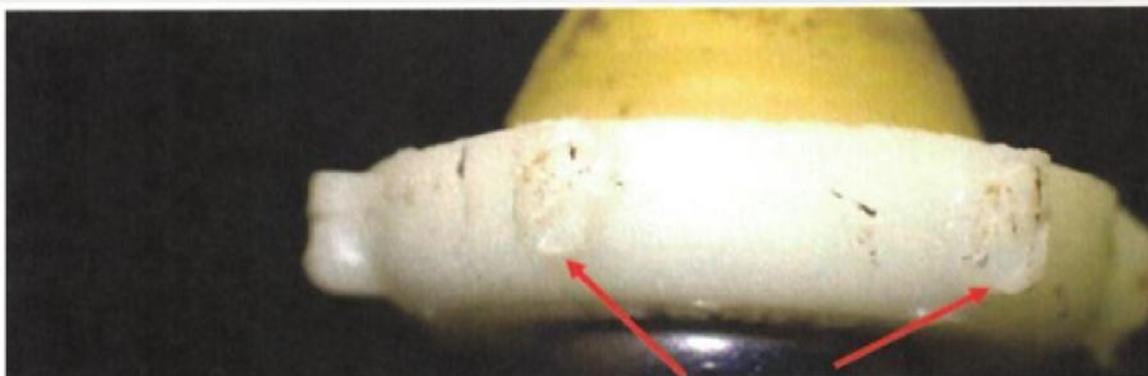
Tool marks found on coupling nut.

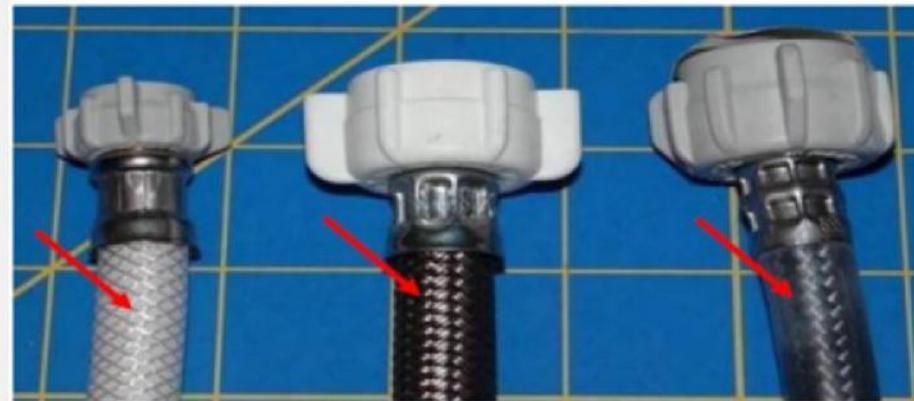
Exemplar supply lines that are readily available are more resistant to the subject supply line failure. Watts supply line with polyvinyl-coated exterior (left). BrassCraft supply line with engineered polymer braiding (center), and Watts supply line with exterior plastic jacket used to protect braiding (right).

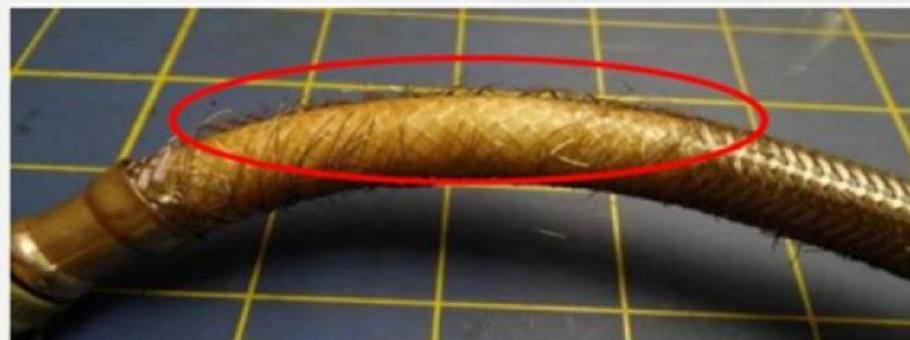
The stainless-steel braid of an exemplar Watts brand supply line that has corroded due to chloride exposure. Note the reinforcement of the inner polymer tubing prevented the supply line from bursting and leaking.

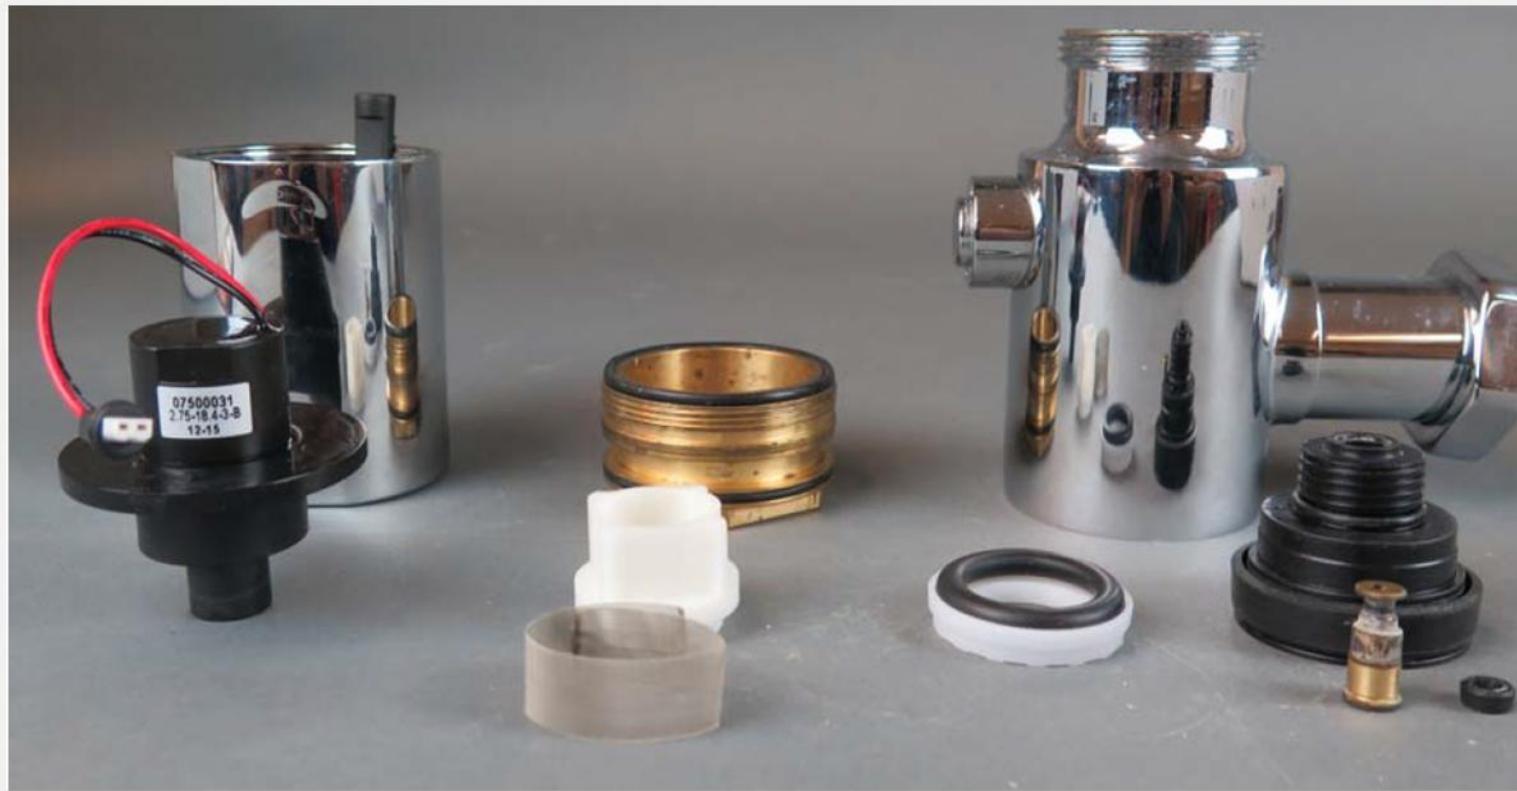
Continuous Flushing

1.3 gpm leaking from fitting
